Docket No. 217 – Development and Management Plan Inspection

Date: February 2, 2005

Location: Norwalk Substation Expansion

Location: Plumtree Substation Expansion , Bethel

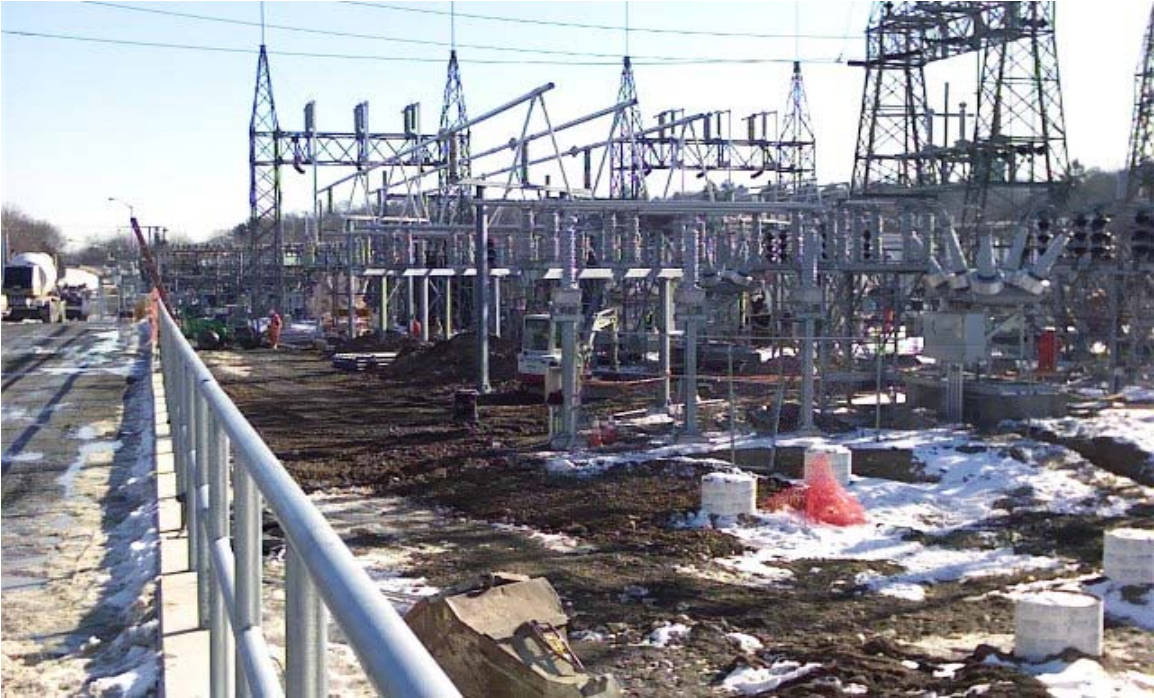
View of the excavation and backfill work south of wall #3 for construction of conduit banks and utility vaults. All areas are well contained at this time. 2/2/05

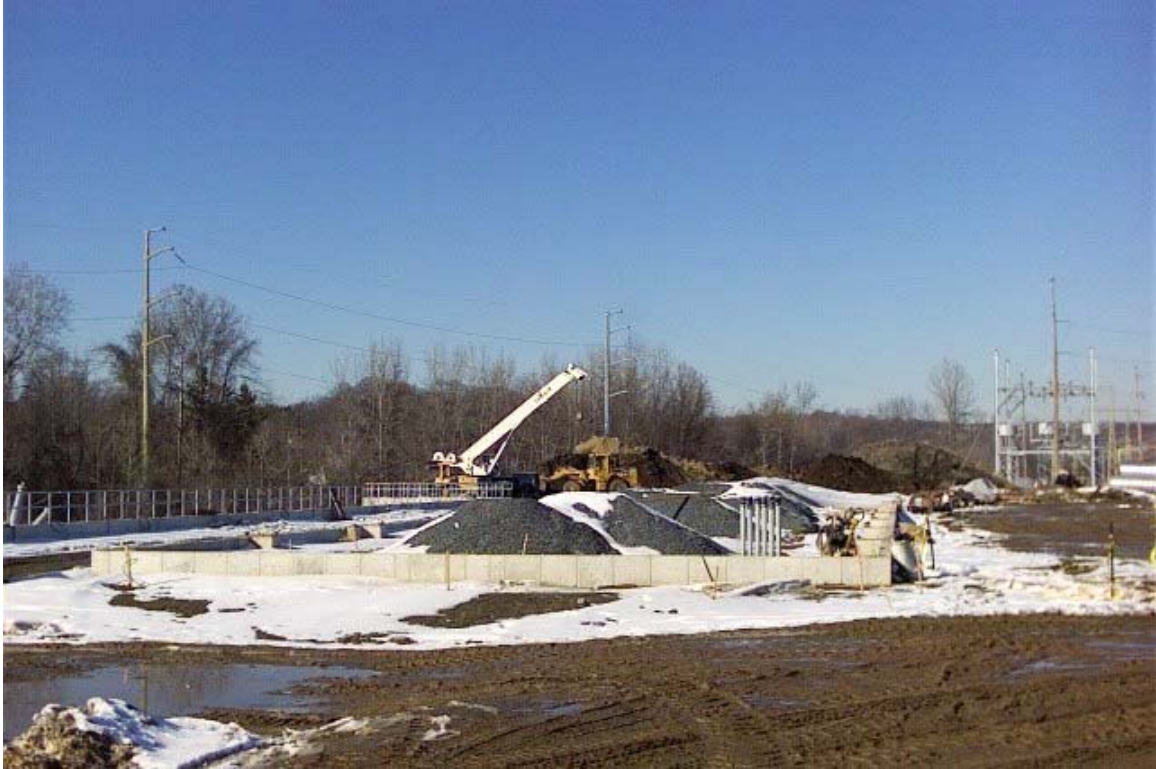
Overall view of the GIS building work. 2/2/05

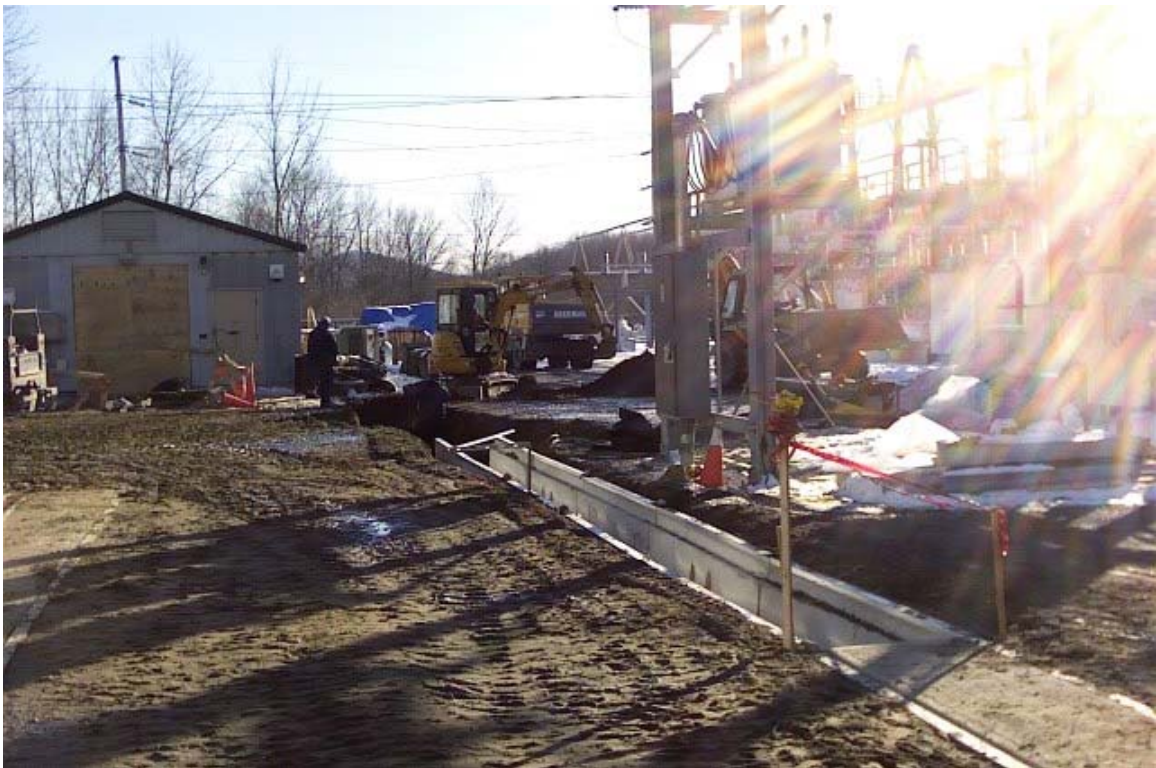
Plumtree Substation: Due to soil warming, work continues on the cable trenches near the trailers and is extending out near the entrance to the yard. 2/2/05

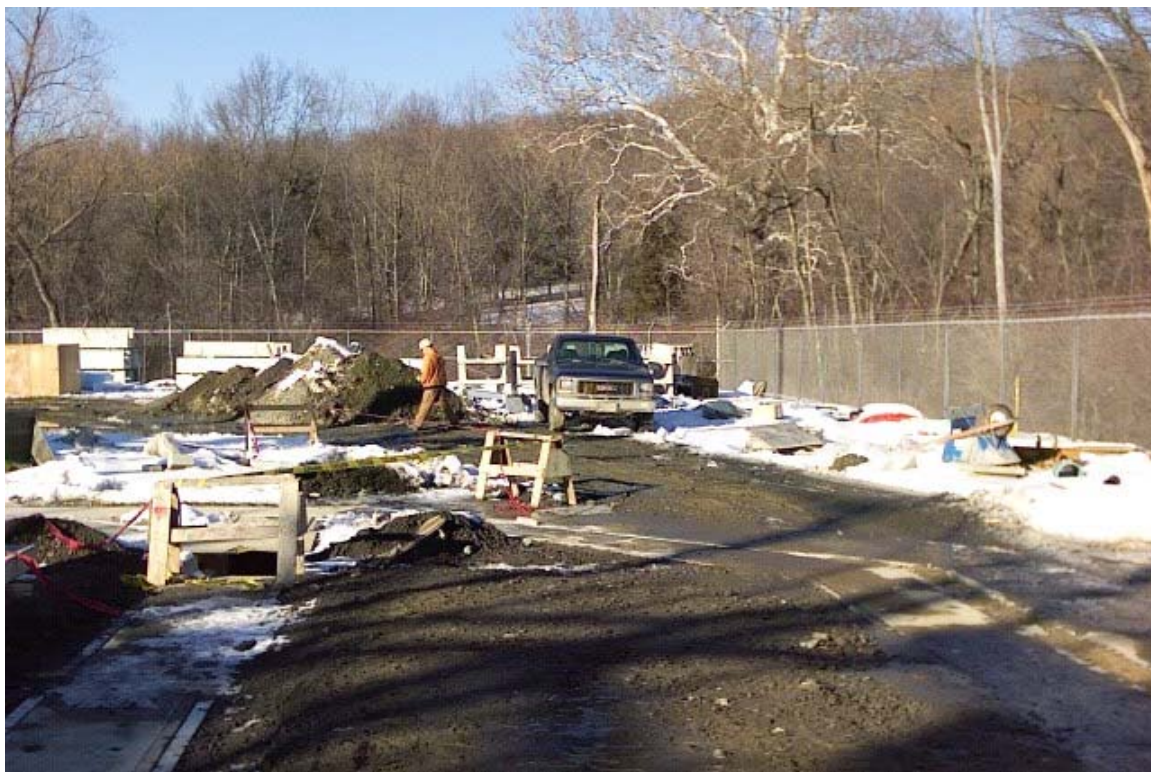
View of the recently backfilled portions of the trench work with the perimeter area still covered with snow. 2/2/05

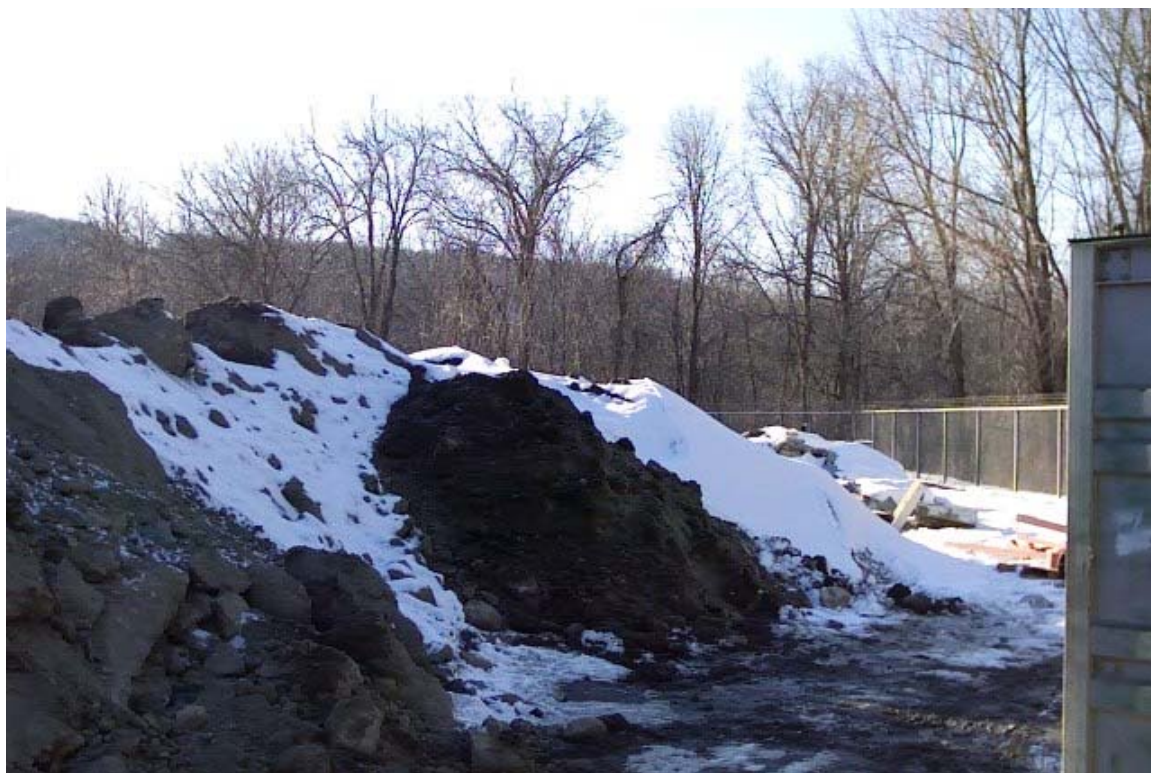
- Portions of the stockpiles of soil are still being actively worked. Intermittent removal of extra soil to appropriate off site locations is ongoing. 2/2/05	-Continue to keep piles which are still on-site, covered/protected with plastic. 2/2/05
Inland Wetland and Watercourse encroachment and mitigation	- Wetlands are located around the outskirts of the substation yard. Work is fairly close to the perimeter fence but there is no noted sedimentation to the wetland area. 9/10-2/2/05	- The stone berm around the perimeter of the yard continues to prevent sedimentation and water from leaving the site and getting to the wetland edge. 9/23-2/2/05
State species of concern, threatened and endangered species	- No species of concern are located in this area of construction.	- N/A
Vegetative clearing limits (including trees to save or danger trees noted)	- No vegetation outside of the substation yard will need to be cleared during the expansion work.	- N/A

View of some of the working stockpiles on site at this time. Intermittent removal of portions of extra soil from the site is ongoing. 2/2/05
